SPECIAL FEATURES OF THE PROJECT

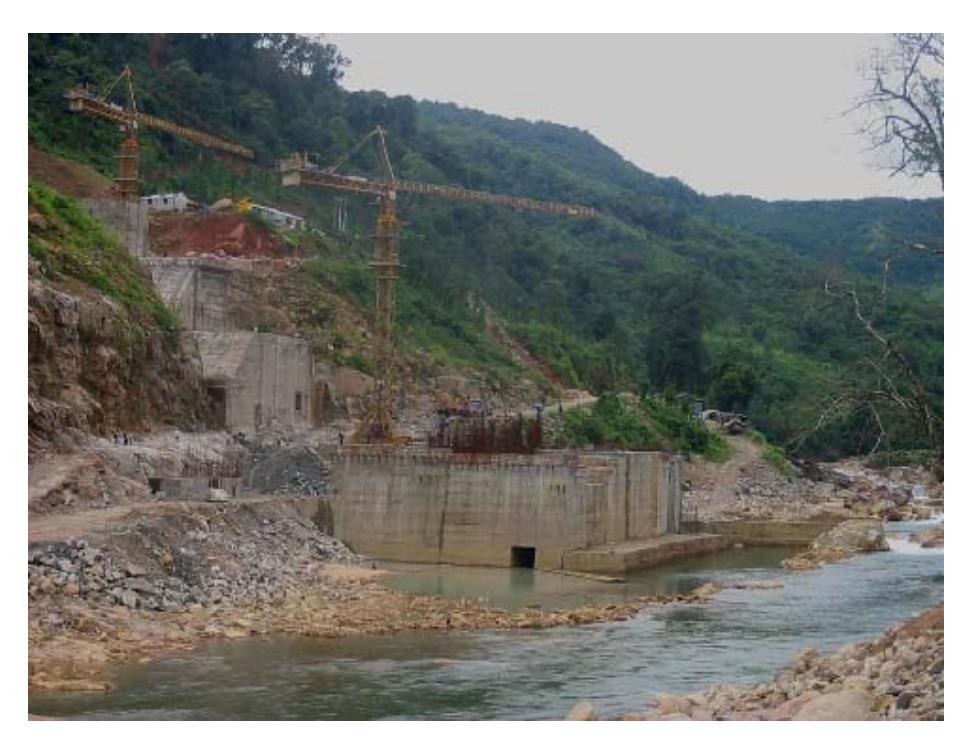
A BIRD EYE VIEW OF THE DAM UNDER CONSTRUCTION

No Diversion Tunnel has been provided. The water has been diverted through the river using divider wall upstream and downstream coffer dam.
